## Track and Support Rehabilitation 1975 on Black Mesa & Lake Powell Railroad

Gerald P. Raymond  
*Queen's University, Kingston, Ontario, Canada*

## TRACK AND SUPPORT REHABILITATION 1975 ON BLACK MESA & LAKE POWELL RAILROAD

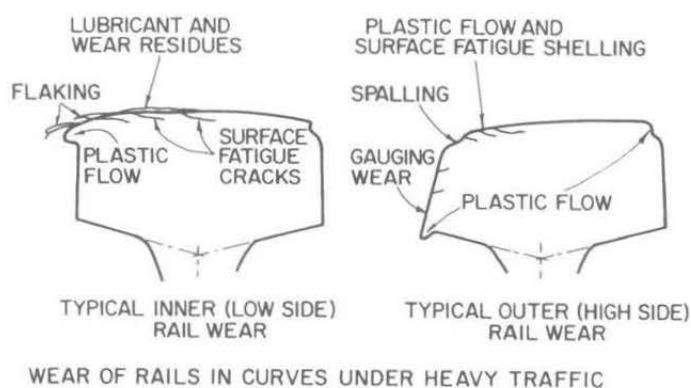
Track inspection involved examination of 20 ties at each mile post plus all track on curves of 30 minutes and greater and identified four topics, related to the track, for further consideration. These were:- (a) Rail structural capacity and rail head wear on all curves. The condition of the rail head is illustrated in Fig. 1. (b) Tie clip/tie shoulder and tie pad performance. The condition of the tie clip/rail seat and soft pads are illustrated in Fig. 2. (c) Concrete tie versus wood tie performance. (d) Ballast particle surface shape and origin source. There were no noted problems related to drainage or the subgrade.

Fig. 1. Typical form of rail head damage.

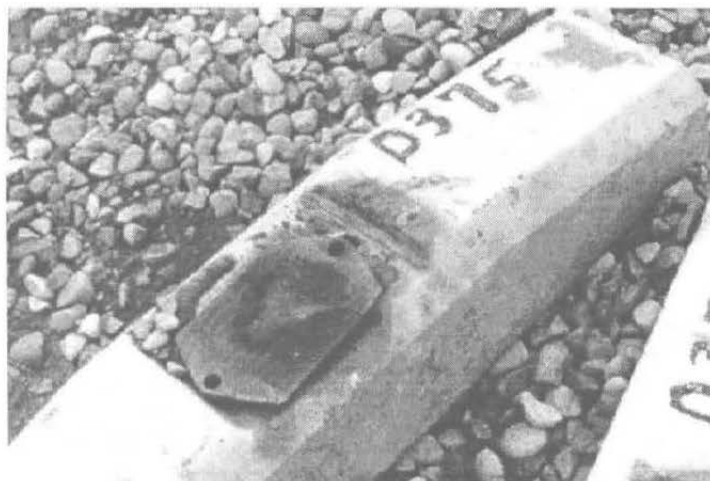
Fig. 2. Typical tie seat damage.

There was obvious major tie holding instability on the curves. Calculations showed that the concrete tie track with its 26.5 inch (0.669 m) spacing would have a 10 % stronger lateral strength than wood ties at 19.5 inch (0.492 m) spacing. Considering only the holding capacity of the ballast there would be a disadvantage to change to wood tie track, however this neglected the consideration of rail/tie bolt failures. The railroad commenced a replacement of the concrete ties by wood ties on all curves without replacement of the ballast despite a warning that changing the ties without more stable ballast (through more crushed faces) could result in a derailment. Indeed such a derailment did occur on the new wood tie (curved) track. Unfortunately no cause was investigated due to the urgency of moving coal, however the derailment strengthened the urgency for a new ballast on any curve with wood tie track (as discussed later). The original soft pads allowed excessive rail movement and resulted in severe shoulder spalling. As given in Table 1 about 18,000 spalled shoulders existed in the curved track. The percentage of spalls increased as the curvature increased. Another 18,900 spalled shoulders existed in tangent (straight) track. Center bound ties (cracked) tended to increase as the curvature increased. These spalls were repaired using epoxy mortar and after a cure time of 24 hours withstood a lateral shoulder force equal to that of new ties which was about 25 kip (111 kN) force per shoulder. Since all concrete ties were being replaced in curves the repaired ties were only used in tangent (straight) track, including a new additional passing track. The repaired ties have performed satisfactorily for over 20 years.

Tie/ballast contact pressures were calculated on the AREA Manual assumption that the ballast contact pressure was uniform, resulting in calculated tie/ballast contact pressure (allowing for recommended impact) of 72 psi (496 kPa) which is less than the permissible maximum contact pressure of 85 psi (586 kPa). Similarly the calculated maximum rail seat bending moment was 228 kip-in (25 kN-m), which was greater than the recommended design value of 165 kip-in (18 kN-m) but less than the lowest tested rail seat bending moment; measured at first crack as 245 kip-in (27 kN-m). None of the removed concrete ties showed signs of rail seat cracks and none were reported to have occurred. The concrete ties were assessed as satisfactory, however 5 % were centerbound cracked. Since there was no obvious increase in the centerbound cracks with increased rate of curvature (Table 1) these cracks could have been due to construction forces. Furthermore, the cracks did not extend more than 1.5 inches (38 mm) below the surface and were considered superficial. An application of a sealer (Fel Pro) was applied to prevent moisture penetration and to permit identification of new cracks.

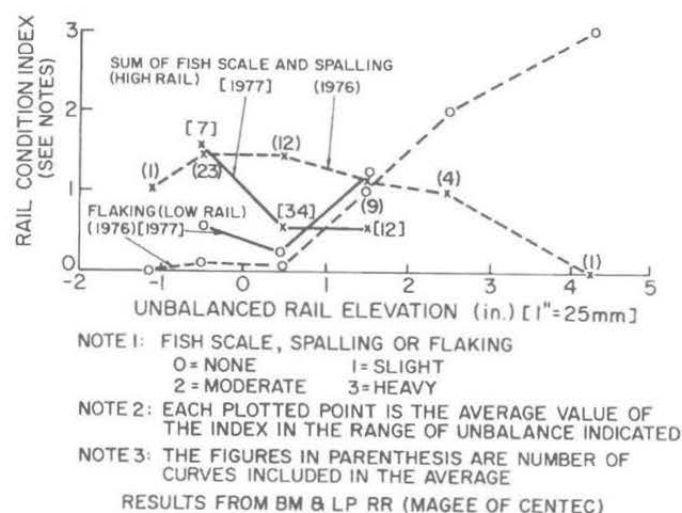
Fig. 3. Results of observations of rail condition in curves on the Black Mesa and Lake Powell railroad.

The rail head damaged conditions observed on the low and high rail head in curves prior to and after re-elevation to balanced speed are illustrate by the plots in Figure 1. The observed conditions were subjectively classified into four degrees of severity: 0=none or no damage; 1=slight damage; 2=moderate damage; and 3=heavy damage. The values plotted are the average from the number of curves noted in parenthesis on the plot. The dashed lines represent the conditions in 1976, and the solid lines the conditions in 1977. Figure 1 clearly shows the improvement achieved from one year of heavy axle loads in the condition of the rail on the rail head by comparison with the observations taken in 1976, just prior to cant balance. Note that over the period of observation no grinding or other rail surface improvement was undertaken.

The improvement demonstrates the importance of ensuring that the foundation ballast is elevated at correct balanced speed cant through all curves. Similarly the forces (particularly lateral forces) transmitted to the track and its support would be improved.
